National Transportation Safety Committee

Final Report

Garuda Indonesia Flight GA 152

Airbus A300-B4

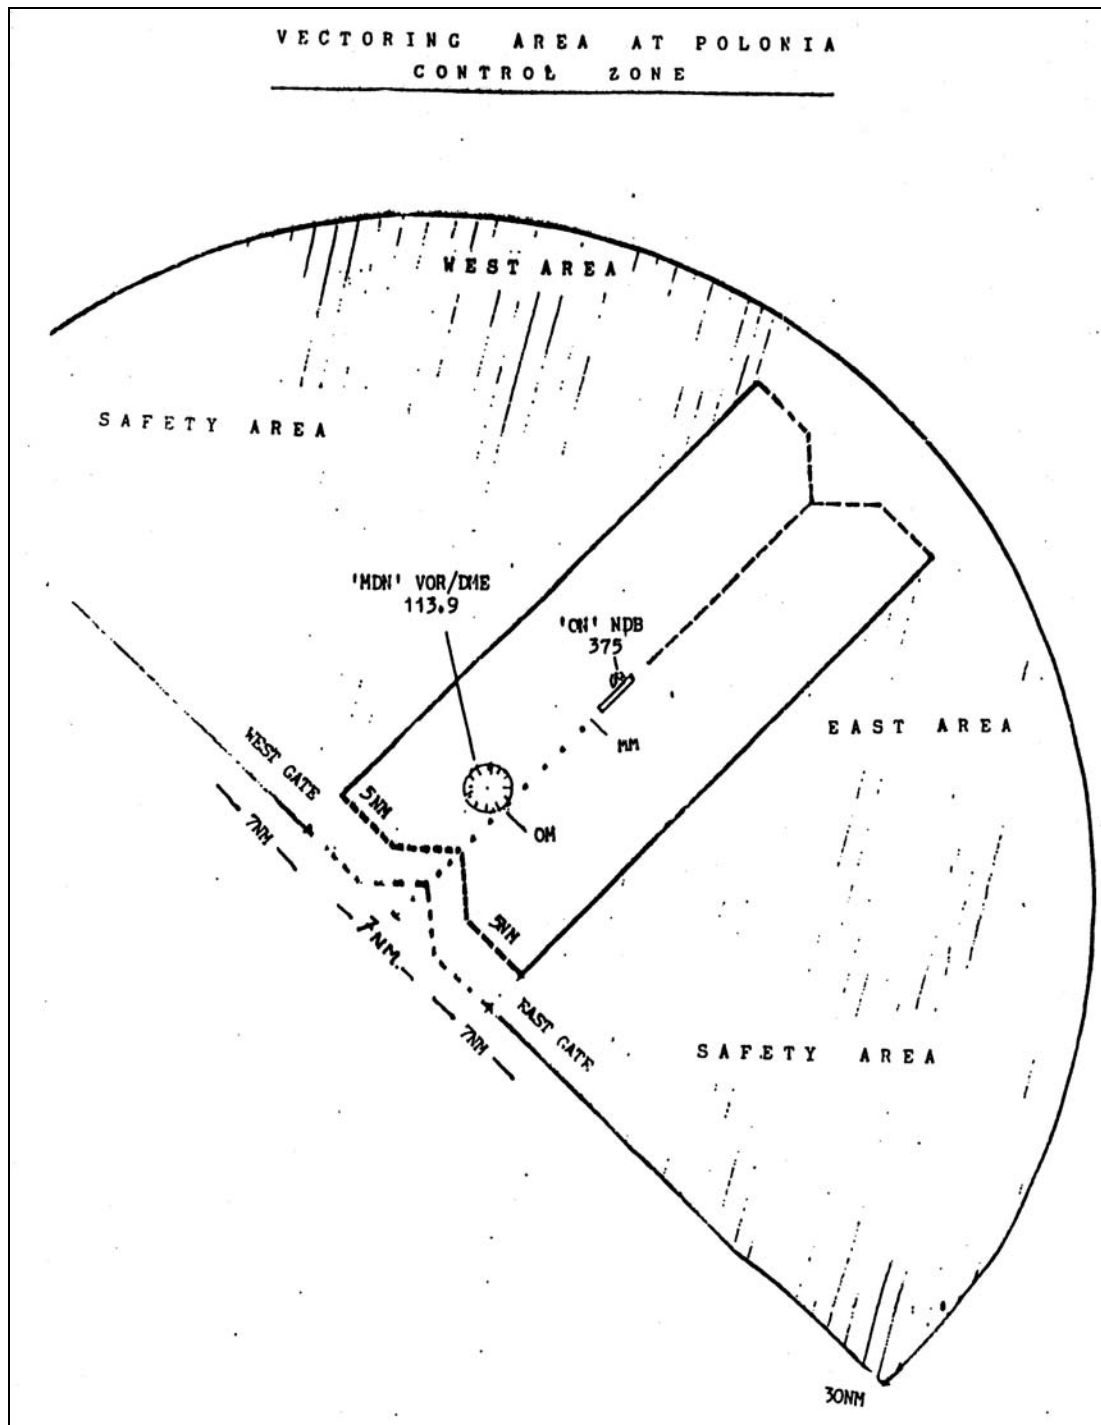
Figure 1. Localizer footprint chart

The localizer footprint map, shown in Figure 1, was displayed on the radar screen for controller reference and showed an area within which the controller may assign 2000 ft while radar vectoring an aircraft for final approach. From the available map, it was indicated that the highest obstacle within the coverage of the localizer footprint is 900 ft.

It should be noted that the Polonia Airport approach control common practice for visual and ILS interception for east traffic was to vector the aircraft to the east gate (see Appendix E and Figure 1), i.e. to intercept localizer of the ILS of runway 05 from the right side. The standard ILS approach to runway 05, however, was to fly overhead Medan VOR, turning left onto heading 226 up to 6.6 NM from Medan VOR, and then turn left onto heading 076 for ILS intercept from the left side of the approach path to runway 05 (see Figure 4).

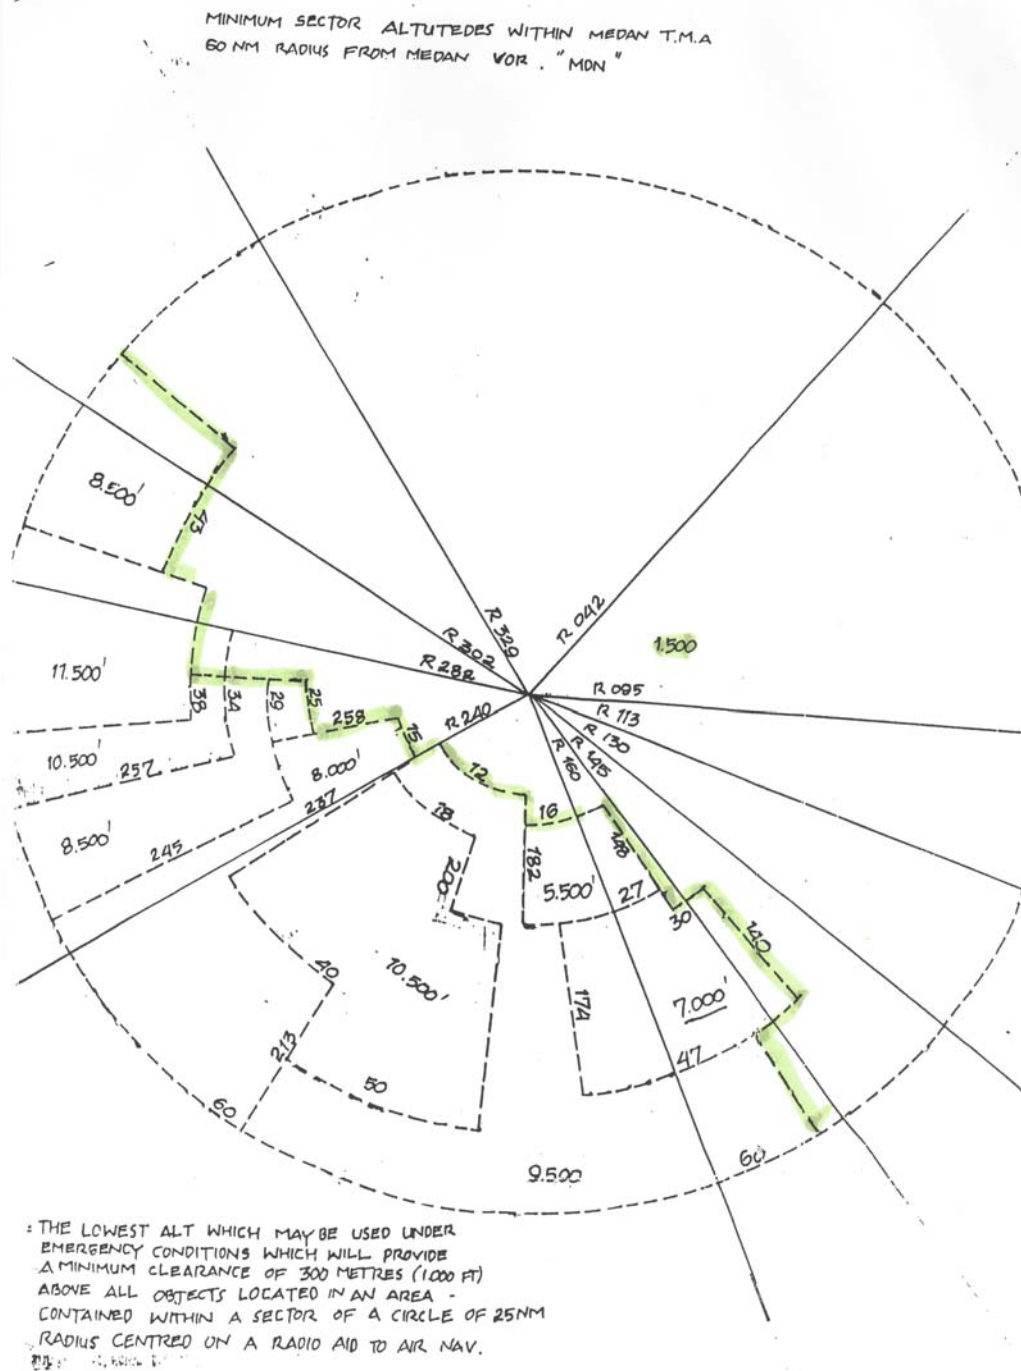
Figure 2. Minimum Vectoring Altitude Chart

The MVA chart, shown as Figure 2, was not displayed on the radar screen but was displayed on the radar console for controller reference. It indicated the minimum altitude that can be used in an emergency and should have provided a minimum of 1000 ft clearance above the highest object in a given area/sector. The areas were constructed in a way that provides many different altitudes at a radius of 60 NM of the radar head position.

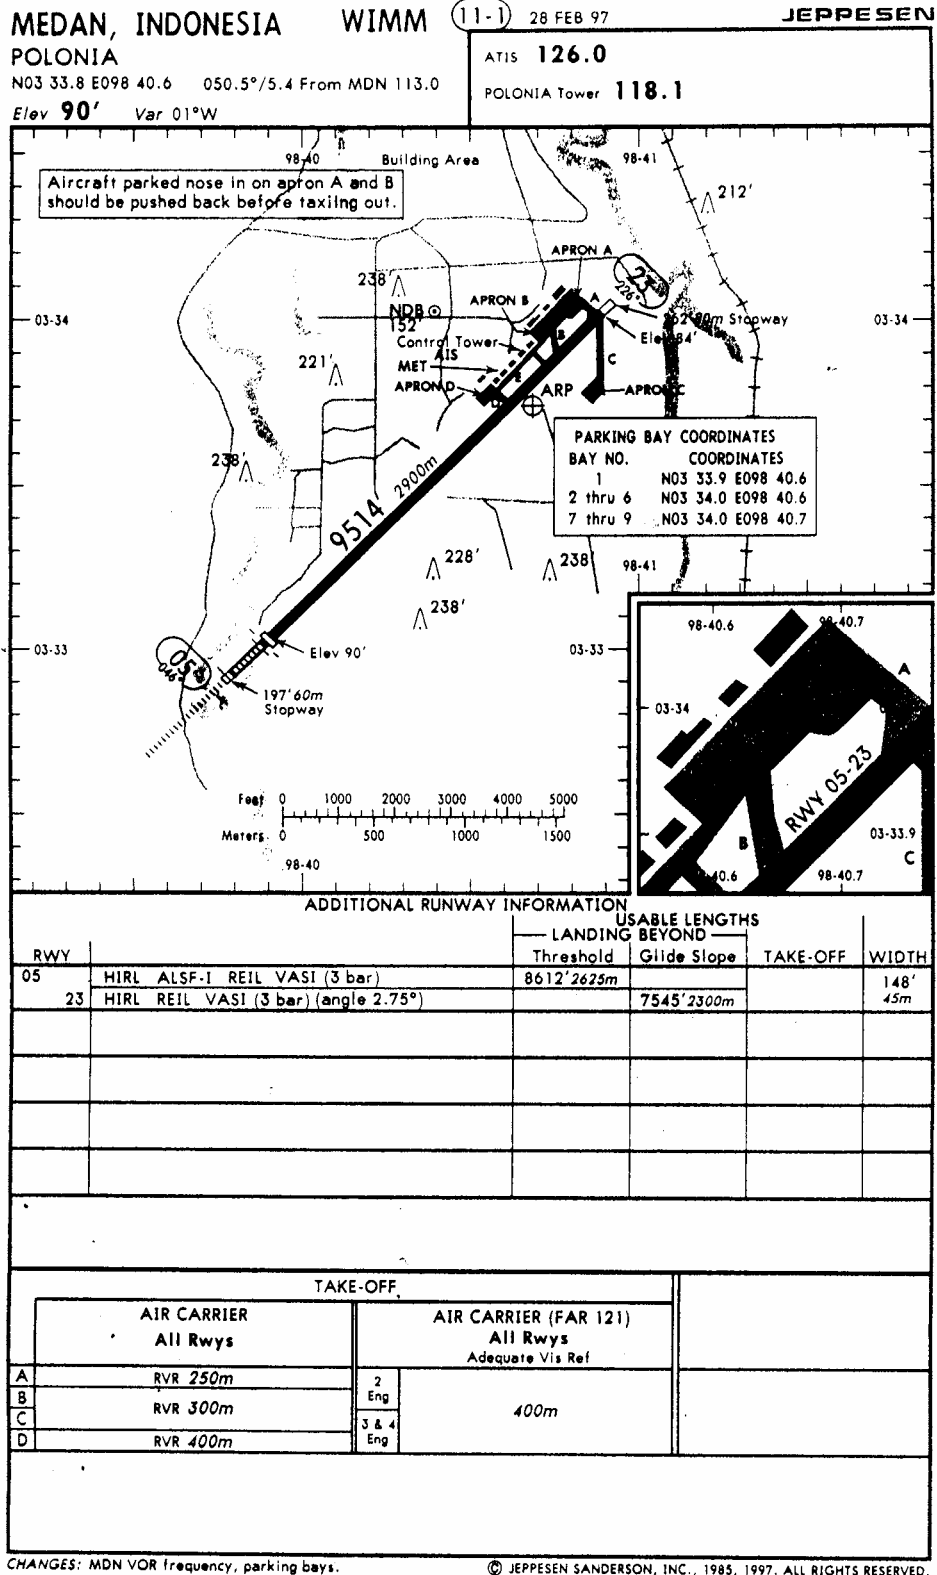
Figure 3. Medan-Polonia Airport Chart (Jeppesen)

Runway configuration of Medan airport is shown in the Figure 3. The terminal building and the apron are situated at the left side and at the end of Runway 05.

The Medan airport configuration is a single runway configuration without a parallel taxiway. The apron location is close to the beginning of runway 23 (see Figure 3) hence runway 05 is most suitable for landings while runway 23 is mostly preferred for takeoffs. This is considered safe for operation during VMC. At the time of the accident, despite the prevailing IMC, the controller activated both directions. This was due to avoid delays in take-off or landing as a result of single direction runway operation. Reciprocal runway operations may result in head-on-conflicting traffic, and may create a hazard to air safety.

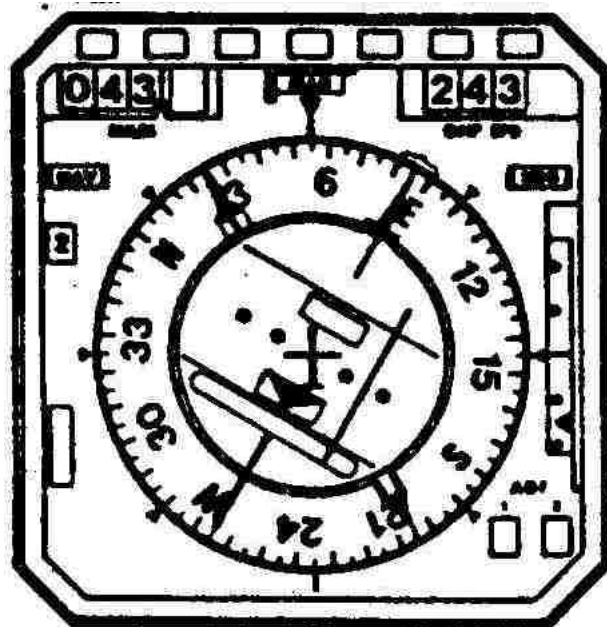
Figure 8. A300B4 Horizontal Situation Indicator

The most relevant difference between A300-600 and A300-B4 FFCC cockpit configuration is the navigational display instrument (see **Figure 8** and **Figure 9**).

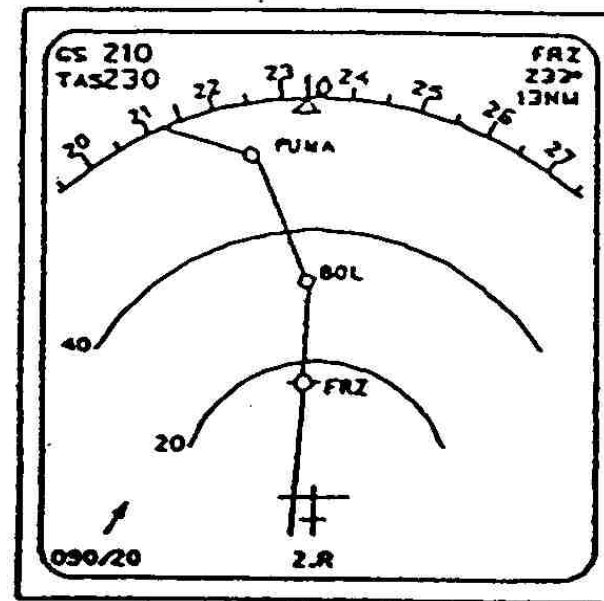
Figure 9. A300-600 Navigation Display

The pictorial navigation display (see Figure 9) on A300-600 will significantly enhance the crew's situational awareness during high workload situation. It seemed that at the time of the occurrence, the PIC had presumably lost his orientation regarding the position of the aircraft partly due to the absence of the pictorial navigation display (see Figure 8), which he then had to "transfer" into a mental picture in his mind. This mental picture, which was later on had to be manifested into a pre-set mind for matters he had to anticipate, may have been a significant factor in determining his subsequent actions, e.g. the crucial issue of turning left or right.

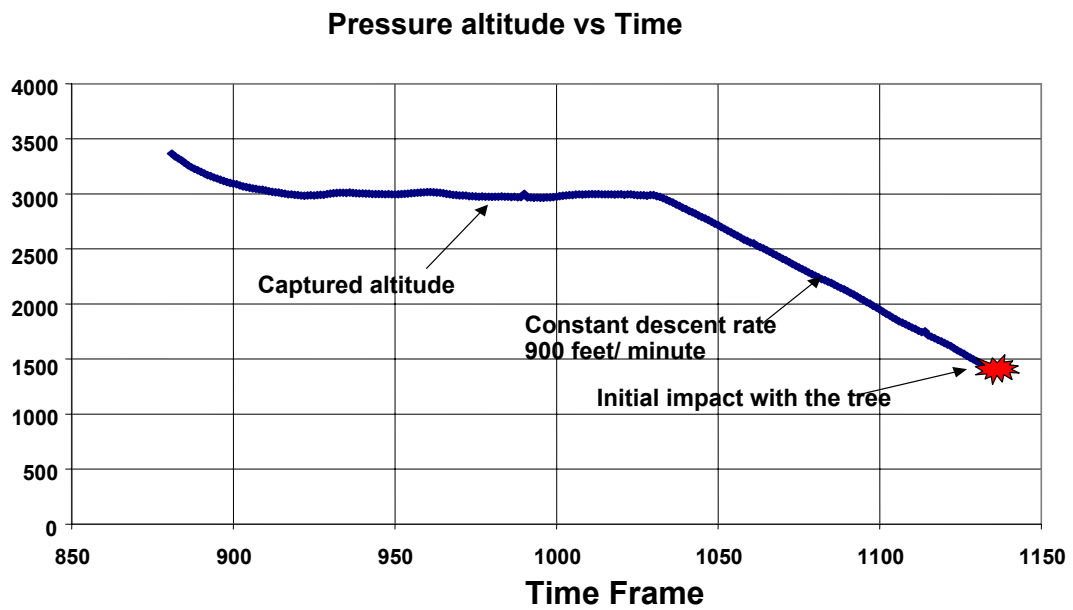
Figure 26. Plot of altitude vs time

The FDR data plot of the aircraft altitude during descent, as shown in Figure 26, indicates several facts, namely:

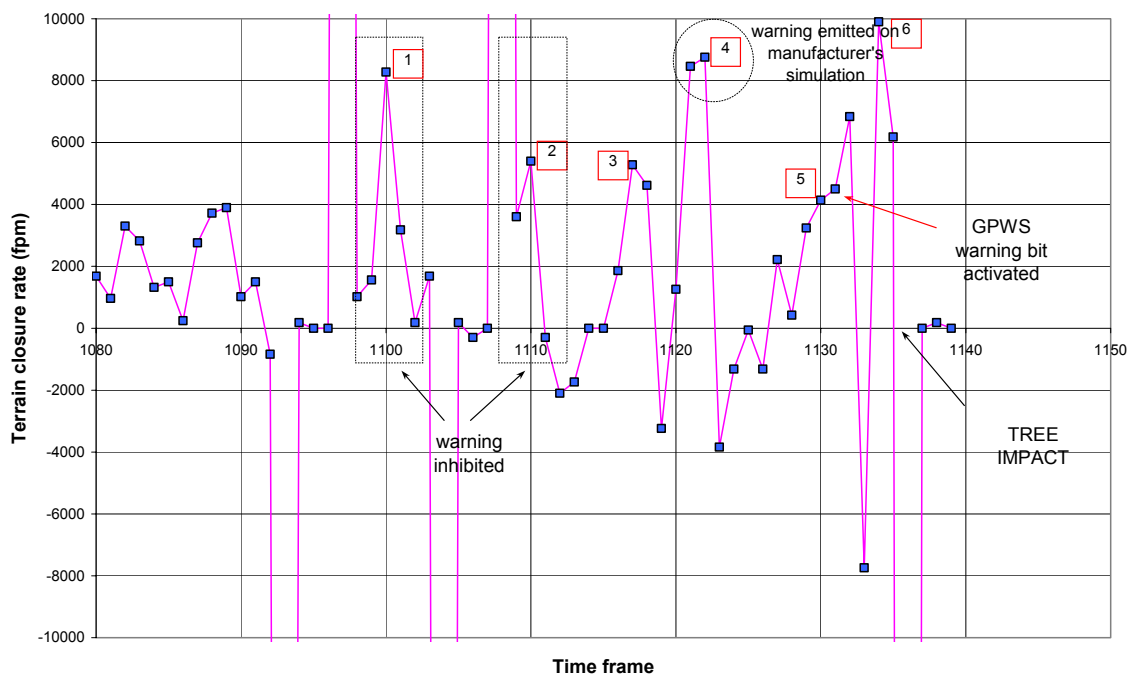
Figure 27. Occasions where GPWS terrain closure rate should generate warning

During the last minute of the flight, there were six occasions (Figure 27) where terrain closure rates higher than the mode 2A envelope were reached. The GPWS manufacturer indicated that such nuisances would be filtered by GPWS (warning inhibited) (Reference G).

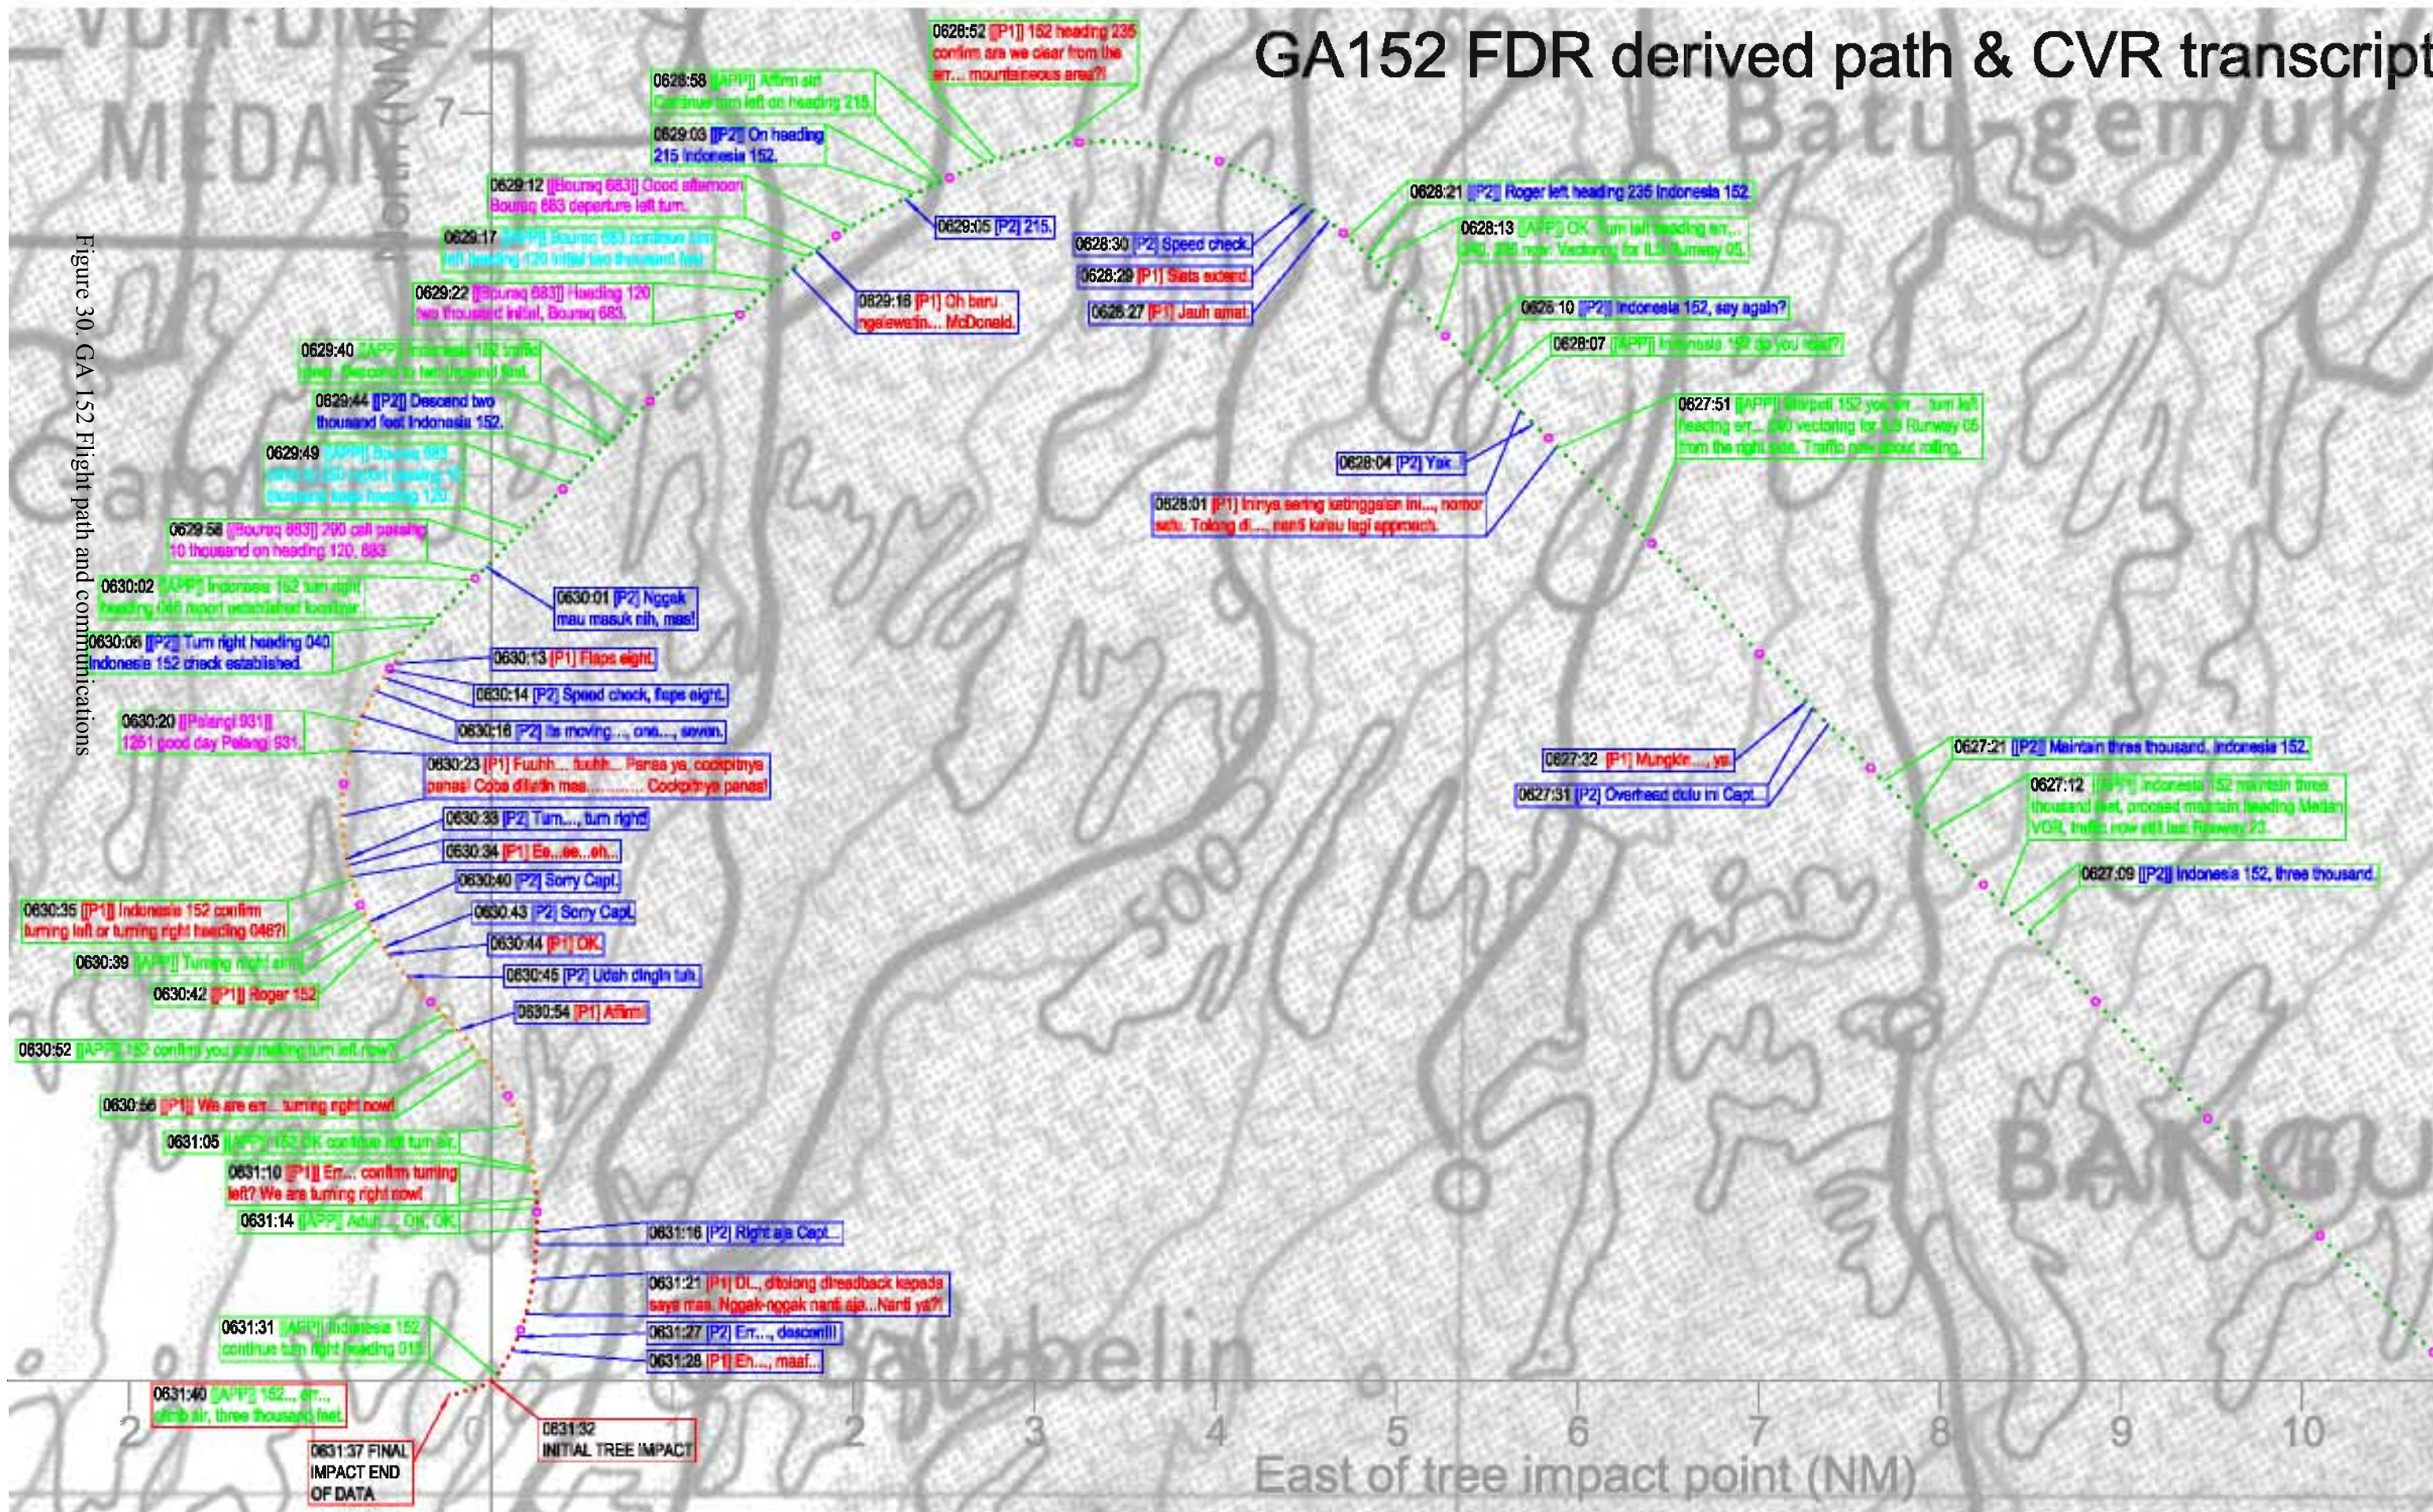
Figure 30. GA 152 Flight path and communications

Plots of several other important parameters which were downloaded from the FDR are presented in Reference A. For analytical purposes, the tabular form of important parameters is combined with the CVR transcript after synchronizing the FDR and CVR time base. It shows the aircraft position, attitude (especially the roll attitude which indicates aircraft turning direction) and the conversations between pilots and the controller (Reference B). The flight path and communications are presented in Figure 29.
